REMEDIAL MEASURES FOR
HOUSES DAMAGED BY
EXPANSIVE CLAY

April 5, 1978

The University of Texas at Arlington
Under Contract No. H-2240-R

U.S. Department of Housing and Urban Development
Office of Policy Development and Research

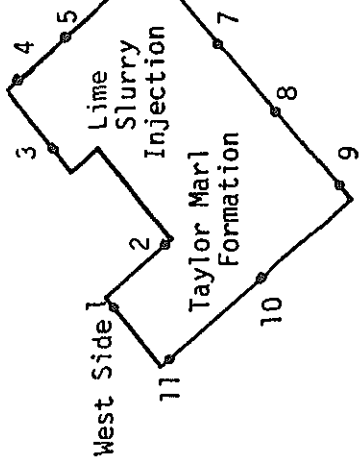
Fig. 14 Differential Elevation on Slab Perimeter

The vertical movement of the foundation slab appears to be approaching a stable condition as indicated in Figure 13, for the same reasons as given in paragraph 3.3.1. Also indicated is the lag time behind the mid point of a climatic cycle. Figure 14 indicates the maximum differential movement with time on opposite sides of the house, and is also given in tabular form in Table 4.

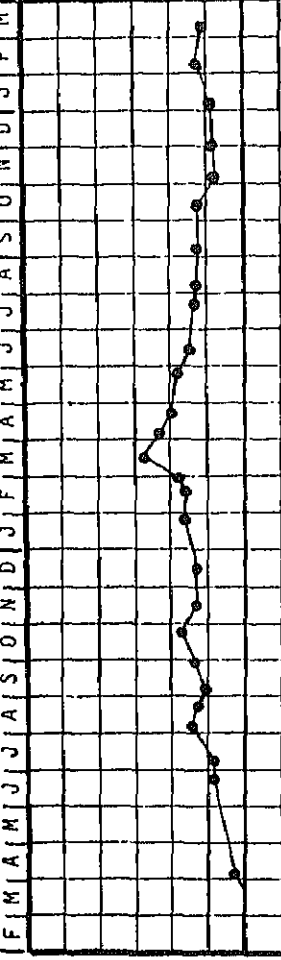
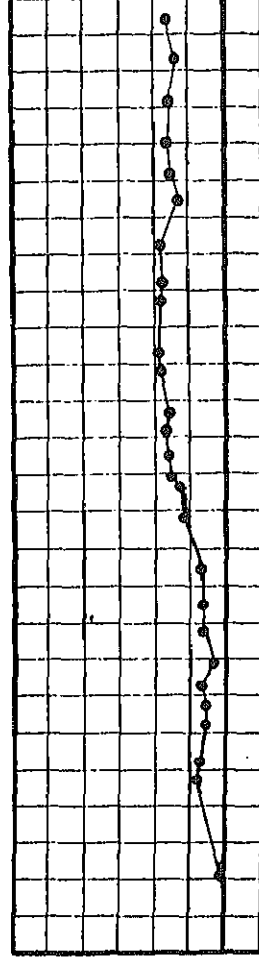
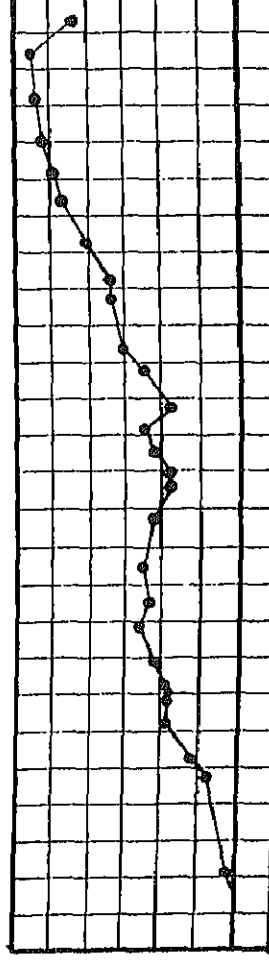
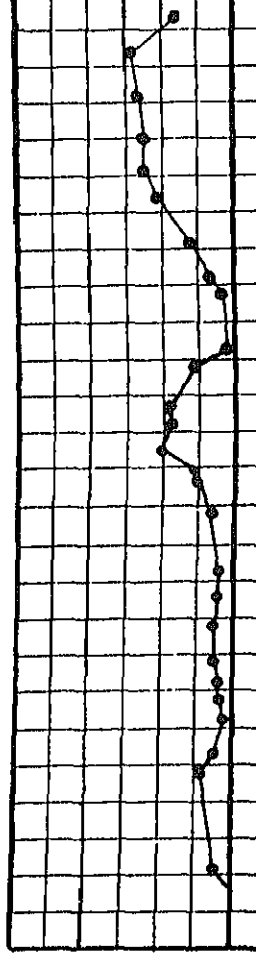
Figure 22 shows the vertical movements along each side of the house as a function of time, and Figure 23 indicates the maximum change in elevation along each side of the house. Data presented is for a performance of two years and represents the climatic effects over approximately two annual cycles. Both the northeast and southeast corners of the floor slab are at approximately the same elevation, with the midpoint along the perimeter beam being slightly higher. The southwest corner is lower; however, change in elevation along the short west side is significant. The south side of this house has the greatest differential movement in corners. Analyzing the configuration of the south side and the data from level pins 4, 5, 6, 7, and 8, would indicate that climate, soil rubbery, and effects of home maintenance are important considerations. The southwest corner and even more so at the change in floor plan shown at level pins 6 and 7 where essentially there are two additional vertical planes subjected to the previously mentioned considerations. The corner at level pin 6 may be postulated as being subjected to the effect of climate, as accumulated data would indicate. In effect, this may be considered an extension or continuation of the length of the test house where climatic effects are more pronounced in

the vertical movements of all sides of the house are significant. Figure 22, the differential movements as given in Figure 23, would have the greatest physical effect on the house floor slab. The change in elevation between leveling points are relatively small, indicating the effectiveness of this stabilization technique. Finally, Figures 22 and 23 indicate climatic effects are being dampened out and the change in elevation between leveling points may be attributed, to some extent, to changes in the subsoil physical properties at different locations around the perimeter of the house.

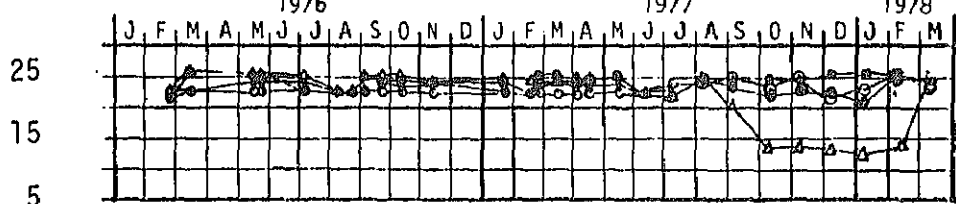
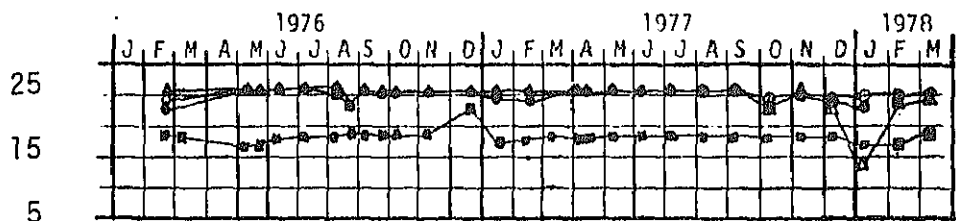
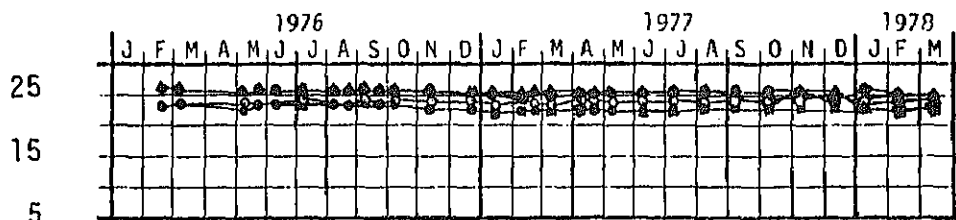
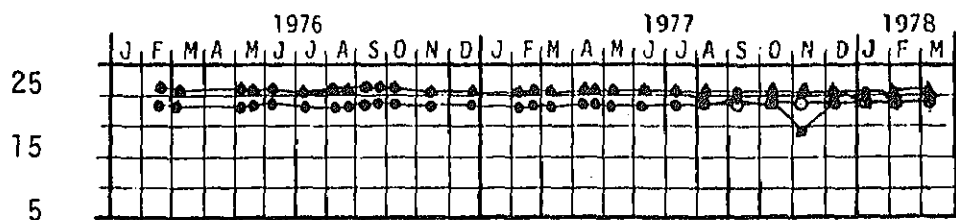
Fig. 25 Soil Moisture Content - Capillary Barrier
1642 Cedar Keys Drive, Lewisville, Texas

The acquisition for variation in soil moisture content with time, as shown in Figure 25, commenced upon completion of actions associated with installation of the capillary barrier as a subsoil stabilization technique. It is apparent that the increase in moisture content in the subsoil at all depths of interest was relatively successful. The narrow band width of soil moisture contents for each depth and with time indicates the stability of the capillary barrier and effectiveness of the capillary barrier in inhibiting moisture loss from the subsoil.

An anomaly is apparent for the curves given in Figure 25, at a depth of 10 feet below the perimeter beam. The moisture cells installed in the boring on the east side of the house indicate a moisture content significantly less than on the other three sides of the test house. This anomaly may be due to variation of soil properties at this depth and on the east side of the house. The investigation boring log indicated a natural moisture content approximately 20 percent above the Plastic Limit at this depth of interest and it is probable that less than desired intimacy of contact is existing between the soil and the moisture cell.

The average natural soil moisture content from the soils investigation was 20 percent to a depth of five feet. The average Plastic Limit to the soil was 20 percent. Figure 25 shows the moisture contents at all depths of the subsoil to be at least 2-3 percent above the Plastic Limit and with relatively constant values with time. The exception to this state-ment has previously been discussed. In addition, climatic effects are not affecting subsoil moisture to any significant degree, within the soil mass encompassed by the capillary barrier.

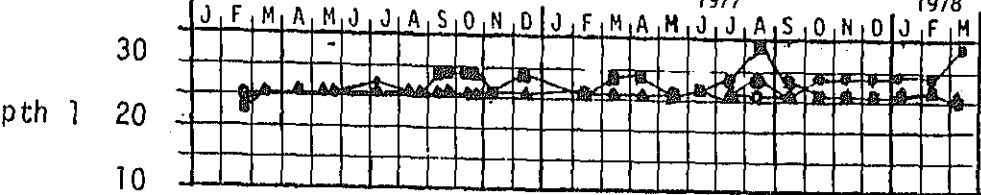
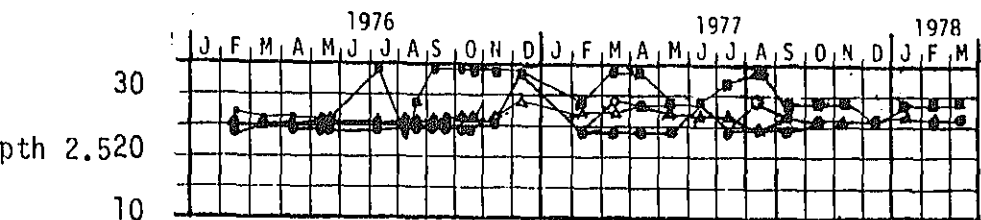
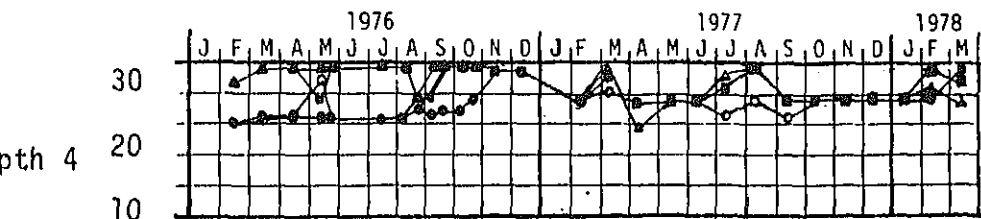
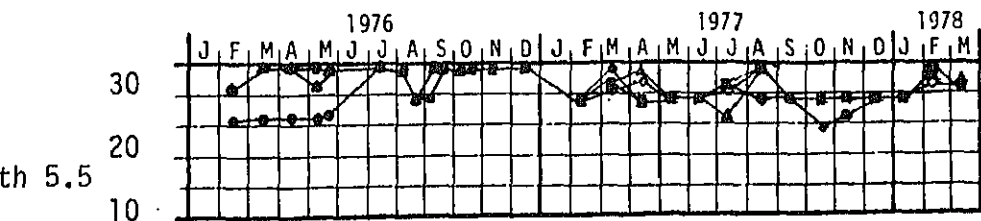
Fig. 27 Soil Moisture Content - Capillary Barrier
9909 Bluffcreek, Dallas, Texas

Data acquisition for monitoring subsoil moisture characteristics with time is given in Figure 27. Acquisition commenced upon completion of actions associated with the use of a capillary barrier as a subsoil stabilization technique. It can be seen that the moisture content to depths of interest were increased and maintained well above the Plastic Limit of the soil. Figure 27 also illustrates the dense characteristics of the Taylor formation. The fluctuation of the soil moisture continued over a period of approximately 8-9 months before stabilizing into a narrow band width. It is noted that the fluctuation of magnitude of soil moisture was in a range above the Plastic Limit which was desired.

The average natural moisture content of the soil within the depths of interest was 13.8 percent, with the largest variation of moisture content below the Plastic Limit being 7.7 percent. The average Plastic Limit within the depths of interest was 19.4 percent with the variation being approximately 2 percent. It is emphasized that any free water associated with climate or home maintenance is not inhibited from crossing the capillary barrier and being taken into the foundation soil, if the soil moisture demand of the clay minerals is deficient in satisfying the double layer water requirement. The objective for increasing the subsoil moisture content was to be minimum of 2-3 percent above the Plastic Limit of the soil. Any increase in moisture beyond that minimum was a more positive action.

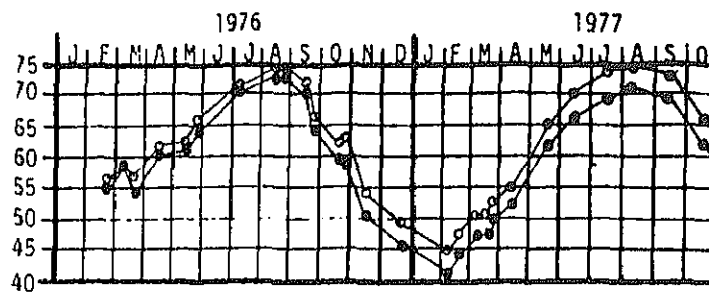
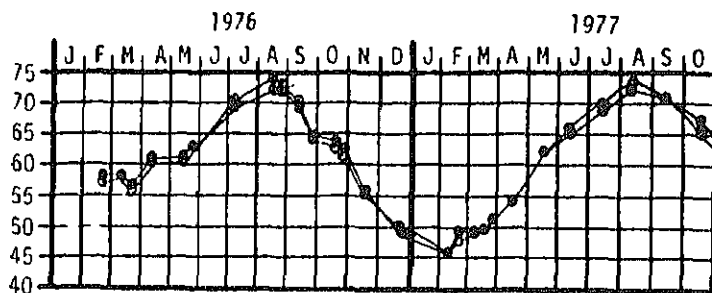
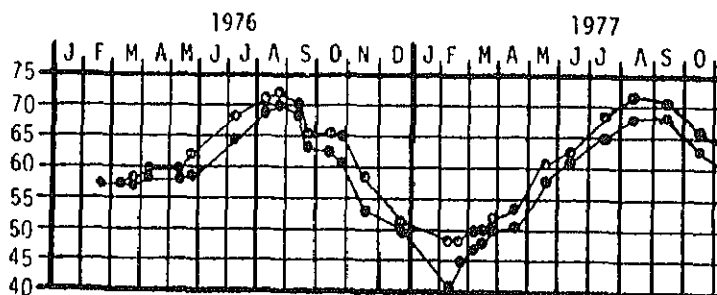
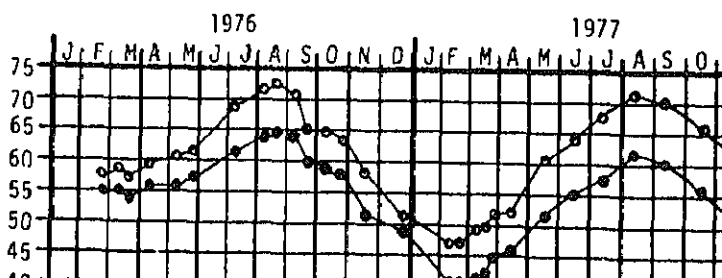
* Refers to Depths Below Perimeter Grade Beam
 Fig. 36 Soil Moisture Content - Rubber Barrier
 1314 Athens Street, Mesquite, Texas

For the test house at 1314 Athens Street, Mesquite, Texas, the variation in soil moisture with time as given in Figure 36, page 80, is relatively uniform at all depths of interest. It is reiterated that a much larger volume of water was introduced into the subsoil surrounded by the relatively impermeable rubber barrier. The soils of this formation are dense and fractured and it was believed a significant quantity of water was able to migrate to great depths and outside of the barrier perimeter. Consequently, a much greater mass of soil, also containing a significant percentage of Montmorillonite clay, was able to experience its swell potential.

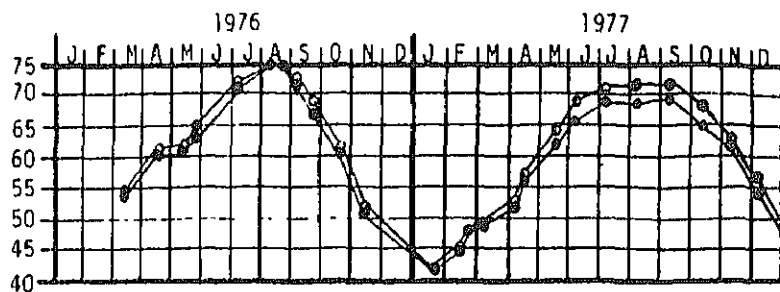
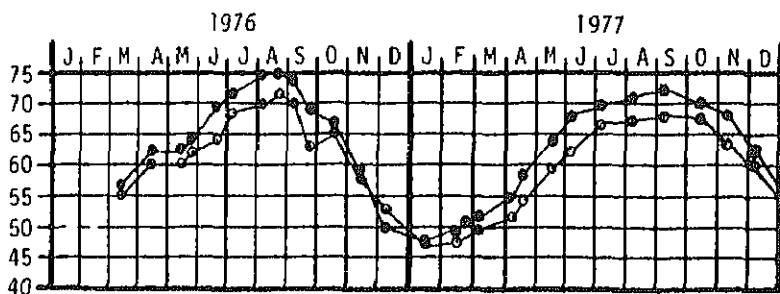
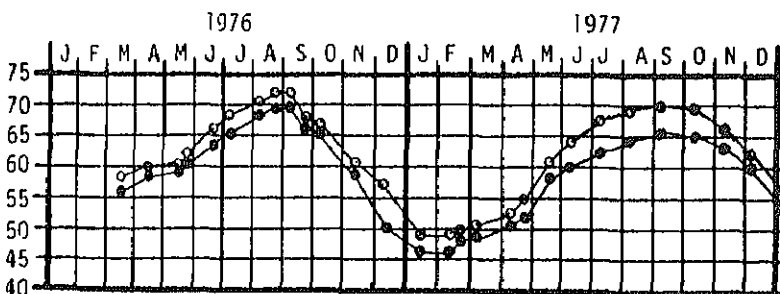
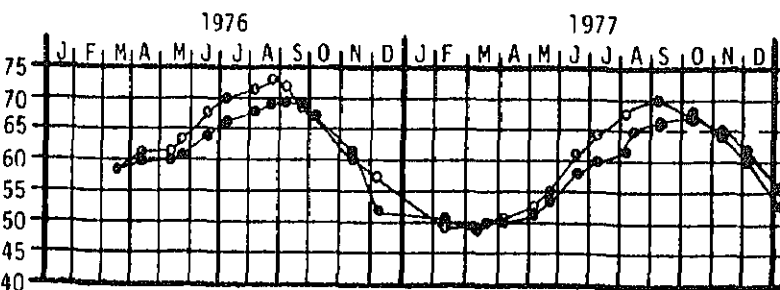
Fig. 43 Soil Moisture Content - Lean Concrete Barrier
1137 Eastwood Drive, Lewisville, Texas

Data acquisition for variation in soil moisture content with time, as given in Figure 43, commenced upon completing all tasks associated with utilizing the lean concrete barrier as a subsoil stabilization technique. Significant variation was noted in moisture contents as a function of time at all depths of interest.

The average Plastic Limit in the upper five feet of the soil at this test house was 24.75 percent. As indicated by Figure 43, the minimum requirement for the soil moisture to be a minimum of 2-3 percent above the Plastic Limit was not achieved for certain depths and different sides of the house. While some reading error is apparent in certain instances, the moisture content as taken from the moisture-temperature cells was not increased to the desired level.

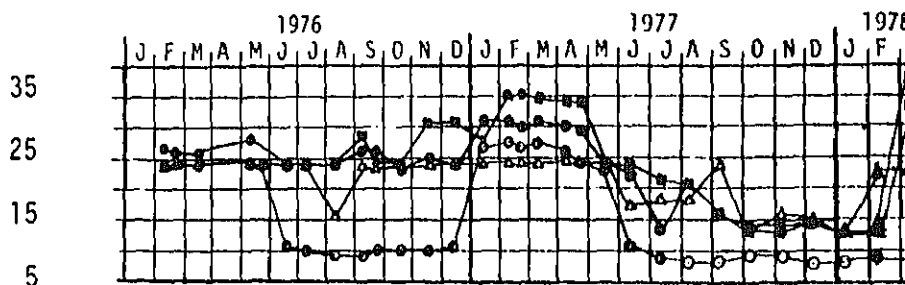
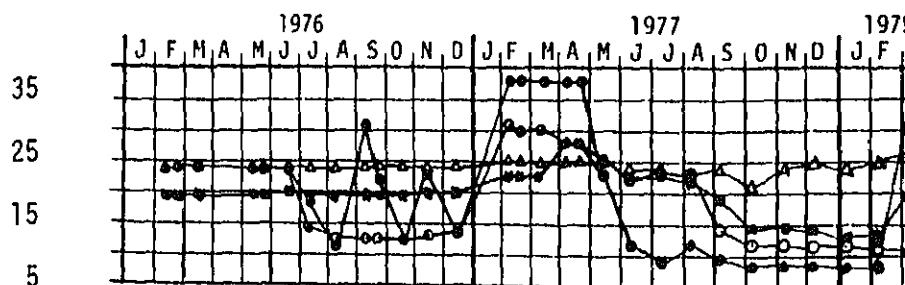
Fig. 52 Soil Moisture Content - Subsurface Irrigation System - 5807 Fess Street, Dallas, Texas

The action of adverse climate is known to initiate soil volume change with time, and corresponding vertical movement. The subsoil moisture data as given in Figure 52 vividly show the effects of climate on moisture stability in a subsoil. The extreme variation with time on all sides of the house and most depths indicates climatic influence over soil moisture.

The investigation established among the index properties an initial moisture content of 24.2 percent at the test house at 5807 Dallas, Texas. The average Plastic Limit was 24.5% with a minimum content below the Plastic Limit of approximately 5%. The content of Montmorillonite clay mineral was 25.8%. All of these for a soil depth of five feet. The relatively close insitu water content and Plastic Limit again illustrates the effectiveness of the effects in causing the soil to give up and take in significant water as indicated in Figure 52, page 116. It is also noted that

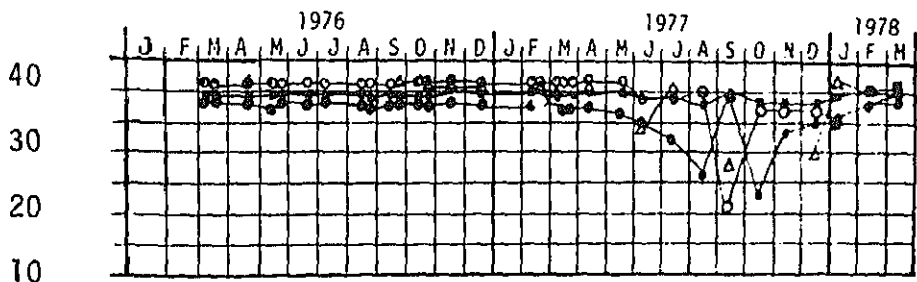
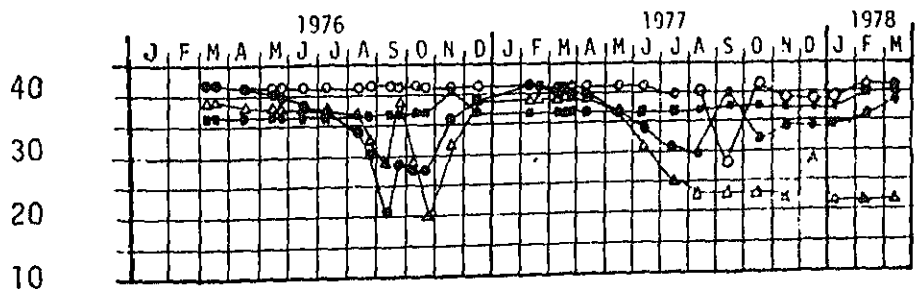
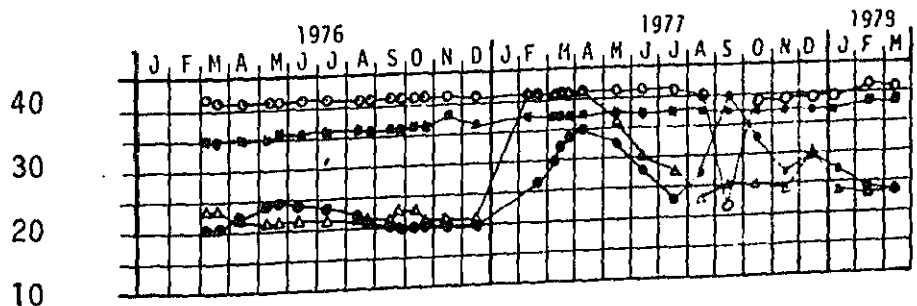
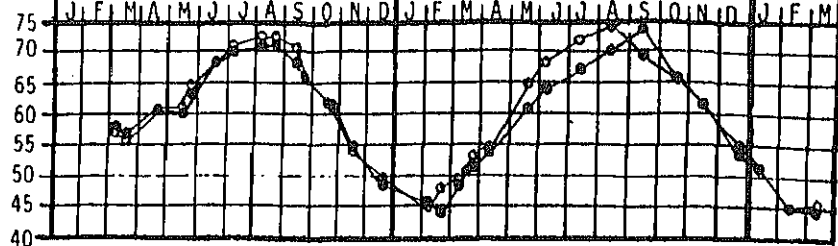
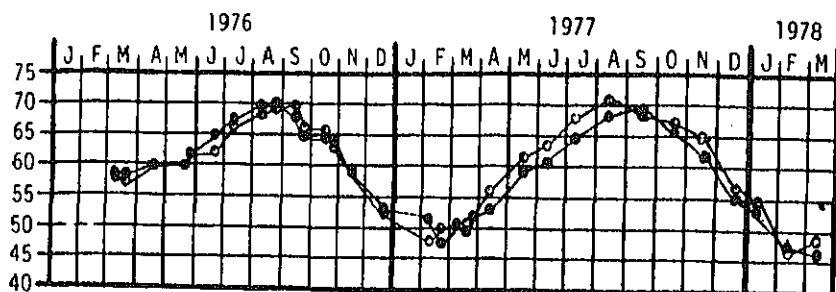
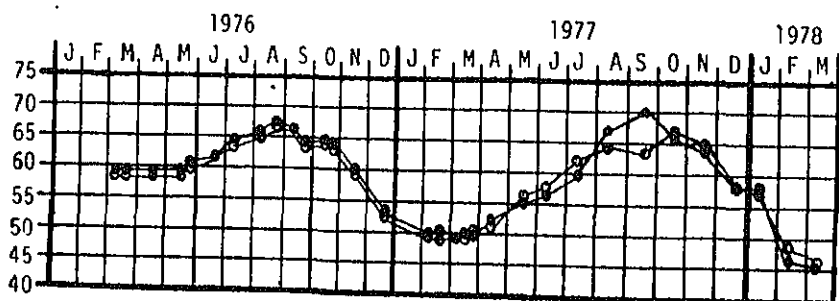
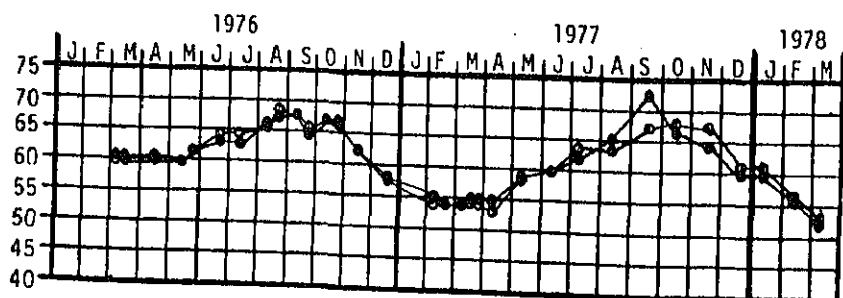
Fig. 54. Soil Moisture Content - Sub-Surface Irrigation

The moisture data given in Figure 54 do not show the extreme variation for this test house as it did for the house on the Eagle Ford f

Data given in Figure 54 are appropriate only for the time the subsurface irrigation system was operative. Beyond that time, data values reflect effects modified by a foundation watering program the new test house initiated after discussion with research personnel.

The effects of climate are not as extreme at the test house at 3513 Heath Street, Mesquite, Texas. The soils investigation established among index properties a natural moisture content of 29.5%. The average Plastic Limit was 31.8% and the maximum deviation of moisture content was 15%. These values are for the upper five feet of soil. It should be noted that the deviation of moisture content given was for the upper one foot of soil. Below the depth the average moisture content of the soil was 32.3 or slightly above the average Plastic Limit of 31.8%. The average percent of moisture was 32.3 within the depths of interest of the soil. As the subsurface irrigation system was installed at the approximate depth of moisture deficit it would follow the moisture content would be raised to the soil moisture demand requirement and remain stable while the system was operative as shown by Figure 54, page 119. At other depths of interest, more variation occurred however, as the natural moisture content existed above the Plastic Limit the demand would be less. This variation, at the lower depths, while the system was in operation, could be caused to some degree by climatic effects but may be primarily due to variations in subsoil properties.
